Manhole Inspection Summary

Manhole # S47G__036MH

Insp Date: **7/30/08 9:32 AM**

Location Address: **204 S Patterson Ave**

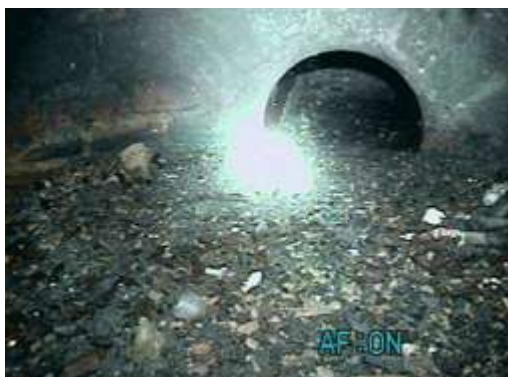
Defect 4

Condition: ☐ Sound ☐ Cracked ☐ Root Intrusion ☐ Deteriorated ☐ Leaks ☒ **Debris**

channel debris

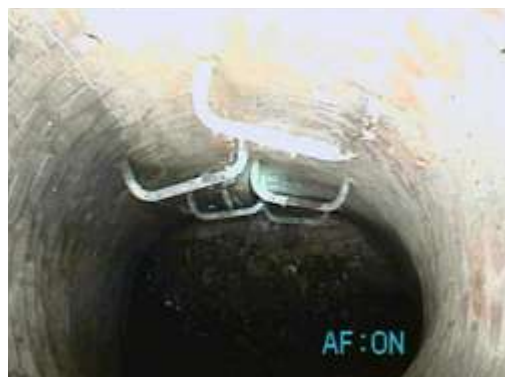
Defect 3

Count: **5** Missing: **0** ☒ **Corroded**

steps

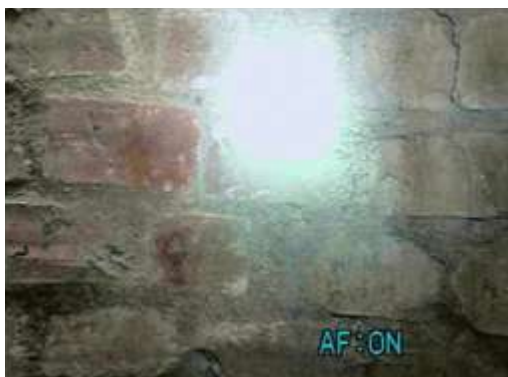
Defect 2

Condition: ☐ Sound ☒ **Cracked** ☐ Root Intrusion ☐ Loose Brick ☐ Deteriorated

corbel cracked

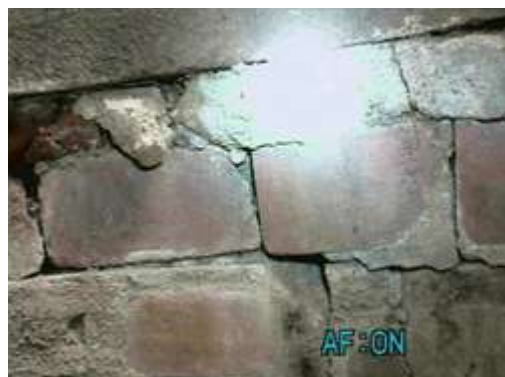
Defect 1

Condition: ☐ Sound ☒ **Cracked** ☐ Root Intrusion ☒ **Loose Brick** ☒ **Deteriorated**

deteriorated cracked, loose brick, frame adjustment
